CHING® Skill-Shot™ Disc Golf Target

SPRING REPAIR

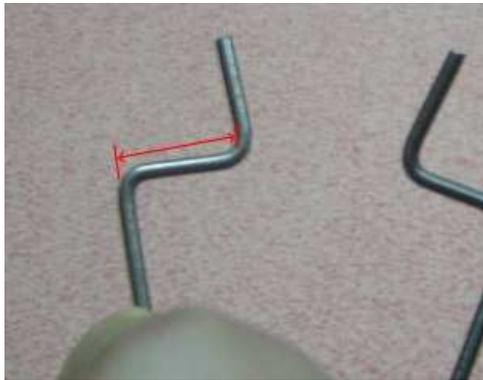
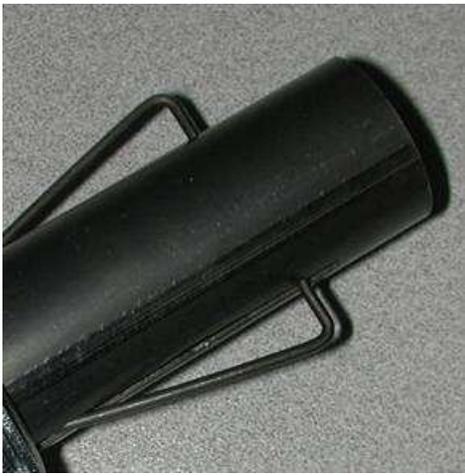
If there's nothing snapped or broken, chances are the spring device is simply misplaced within the pole. Here is how it may appear inside:

One side may have been pushed in too far (all the way) and has become laterally misaligned, so it doesn't return out the slot to the original position. You might be able to 'fish' around with a metal rod or long screwdriver.. something to leverage that side to pop back out into proper alignment. It's possible to get in from the top if the plastic cap is removed... it should just pop off from a pressure fit. You might also access from the bottom if the centerpost is disconnected, but the rivet holding the spring in place will be your first obstacle in this approach.

If you're unable to re-engage the spring, an alternate solution is to drill opposing holes in the pole and use something like a 2-1/2" long, 1/4" diameter bolt to lock the canopy up in position...remove it to collapse. This is how our first prototypes were designed years ago. Setup and breakdown is tedious, but it works.

Production runs are now improved to avoid this; for the spring-release assembly, the width of the lateral support section on either side (where the canopy/basket collars rest in opened position) is shortened. This section was perhaps over-designed in the past with the original stiff/heavier gauge spring, and the wide shelf section - to cautiously make sure there were no collapsing malfunctions.

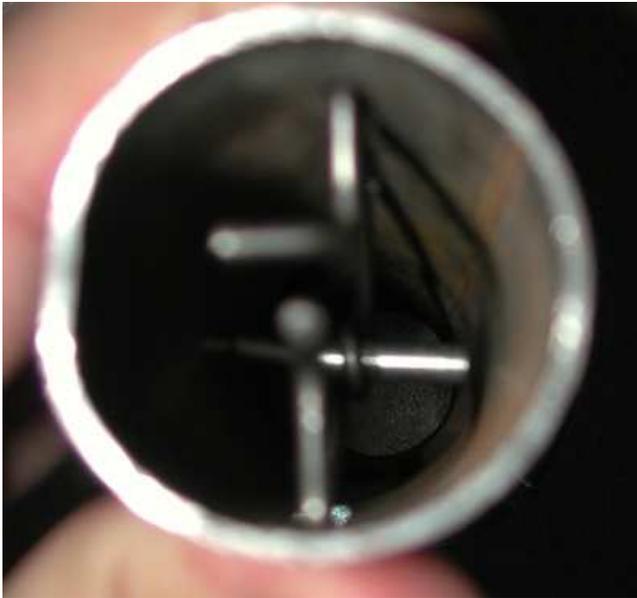
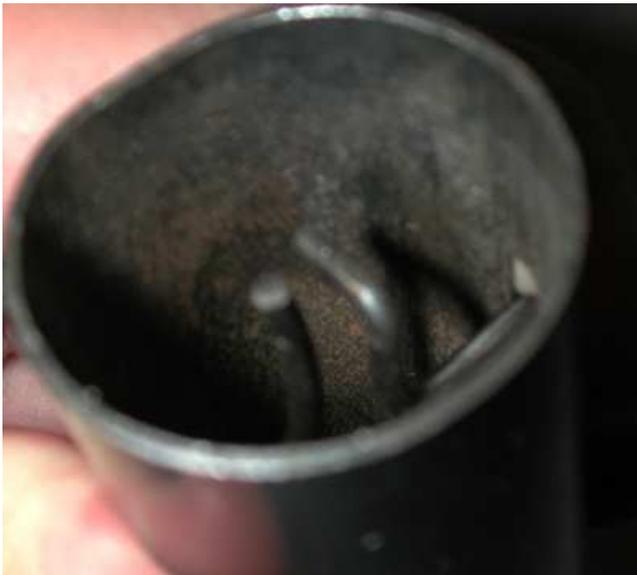
Additionally, if the spring does somehow become depressed too far, the inside is now redesigned with bends at opposing 90* angles on either side to prevent interlocking or snagging - so the spring may be fully depressed and will not pass itself tangentially inside the pole... but should stop itself before the spring goes too far inside the pole and becomes 'lost'. It's not fool proof, but should be a noticeable improvement.
